Used Element Examples

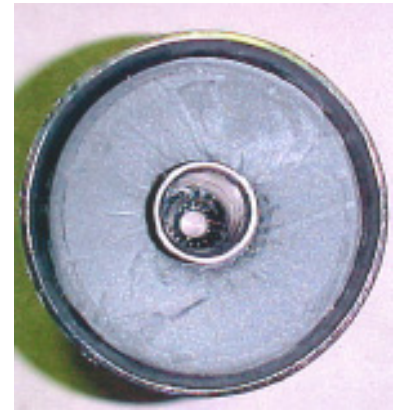
Used engine oil element

The paper is black in colour and is compressed down into the Zytel housing. This is caused from the ingress of soot. As the element becomes blocked the paper media is compressed by the oil pressure. If the elements are not changed regularly or the engine is badly worn the elements will become totally blocked. This will not effect the oil supply to the engine. This stops the by-pass oil filtration process only and in some extreme cases oil may track between the filter media and the Zytel housing.

If the filter media is compressed more than 25 mm into the Zytel housing the elements are blocked. If this continues over a period of several services you may need to add additional Filter Technology systems.

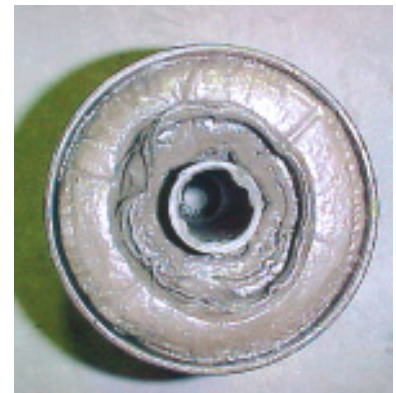
Used crusher oil element

This example shows an ingress of water into the filter media. This is detected by the presence of circular cracks in the filter media. The media will absorb some water. Tracking may occur through the media when the elements are subjected to large amounts of water that may be present in the oil being filtered.

This example also shows a heavy deposit of silicon on the top of the filter media. There are a few reasons why this happens.

- 1) Water damage to the filter media.
- 2) Oil not changed prior to filter installation.
- 3) Damaged countershaft seal or dust seal ring.

Extended element change interval.

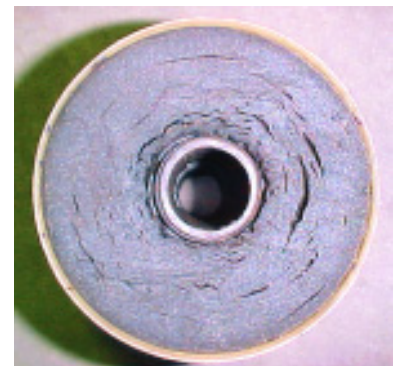
Used fuel pump fuel filter element

The filter media is usually dark brown or black in colour and will only compress down about 5 mm at each end. The following example is typical of a used fuel element. The circular cracks in the filter media are caused by water this is quite common in fuel bowser applications. A large presence of water will split the filter media reducing the elements filtering capacity. If wear metals are present on the surface of the filter media the fuel transfer pump may be worn or the fuel tank has a loose baffle.
